Inspection Report

Sample Report

Your Address

Closer Look Home Inspectors, LLC

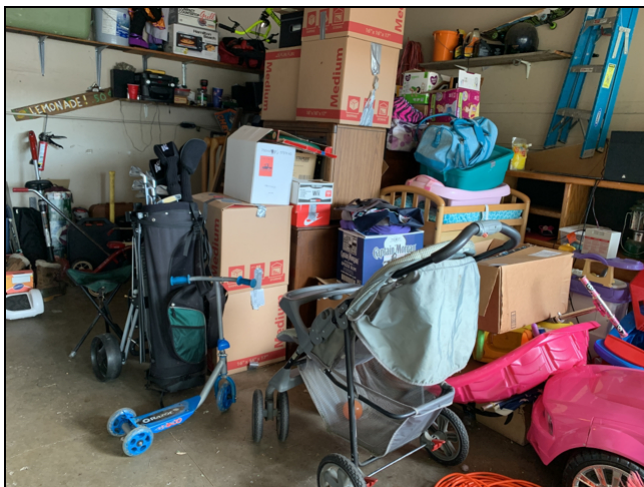
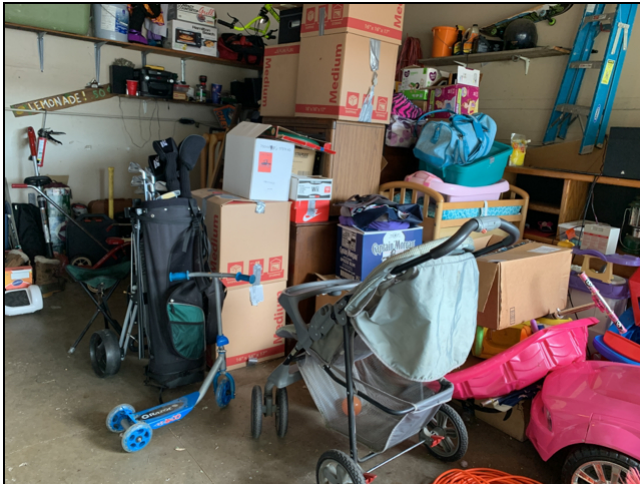
3.1 Item 1(Picture)

(1) Areas of the garage were blocked by sellers personal belongings. I did not move or inspect behind objects. I recommend asking seller to move belonging and further inspect behind objects. We can return for an additional fee to re-inspect areas of the home that were restricted at time of inspection.

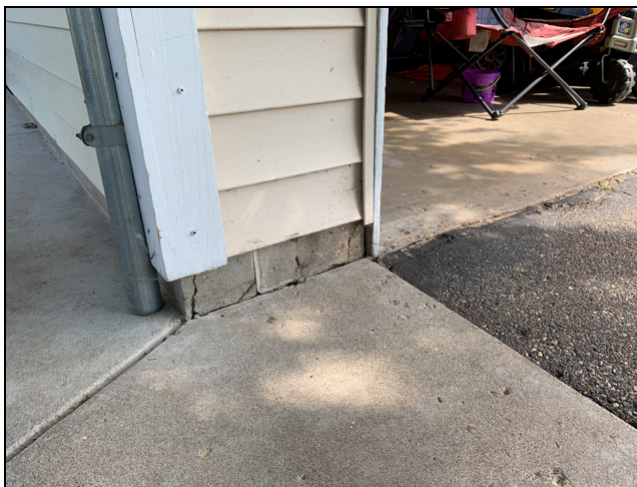
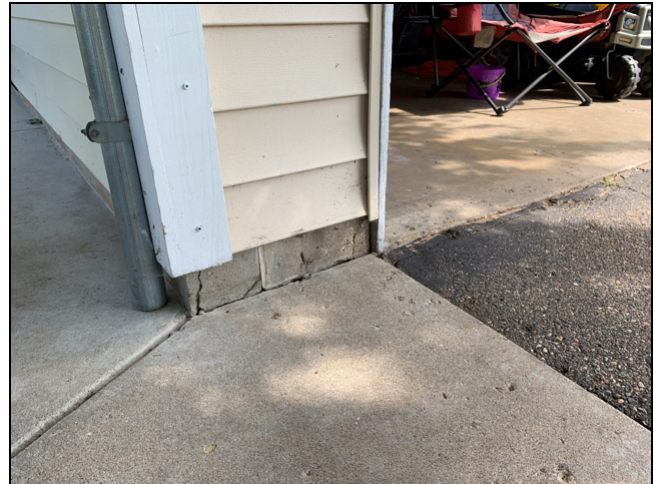
3.1 Item 2(Picture)

(2) Inspector observed what appeared to be a settlement crack at the exterior garage foundation wall. Determining future movement goes beyond the scope of a home inspection. Reducing moisture in the nearby area may decrease chance of further settlement. This is indication of general maintenance. If settlement continues action should be taken to correct. Satisfactory at time of inspection.

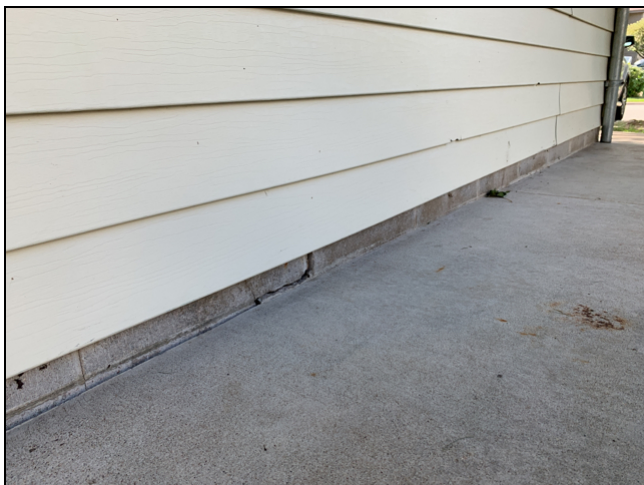
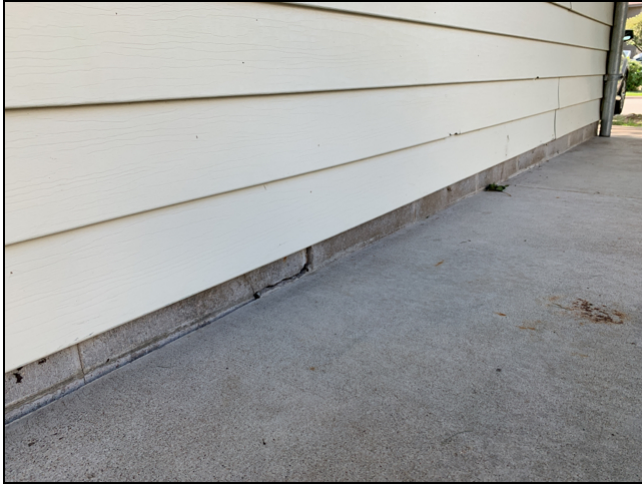
3.1 Item 3(Picture)

(2) Inspector observed what appeared to be a settlement crack at the exterior garage foundation wall. Determining future movement goes beyond the scope of a home inspection. Reducing moisture in the nearby area may decrease chance of further settlement. This is indication of general maintenance. If settlement continues action should be taken to correct. Satisfactory at time of inspection.

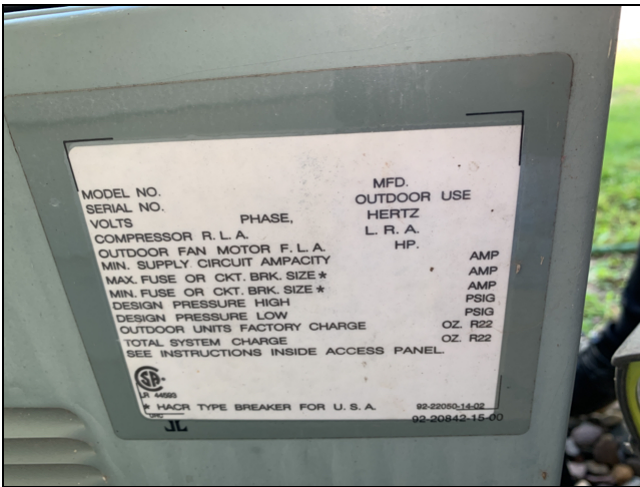
8.5 Item 2(Picture)

(2) The serial number was not visible. Inspector recommends further evaluation by qualified HVAC technician. The air conditioner may be nearing the end of its useful life span.

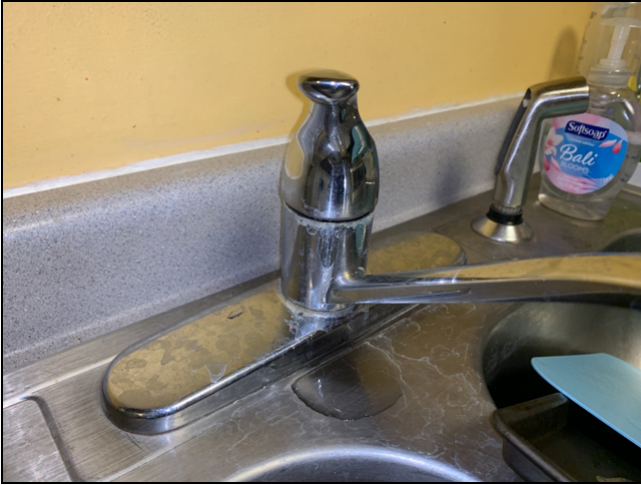
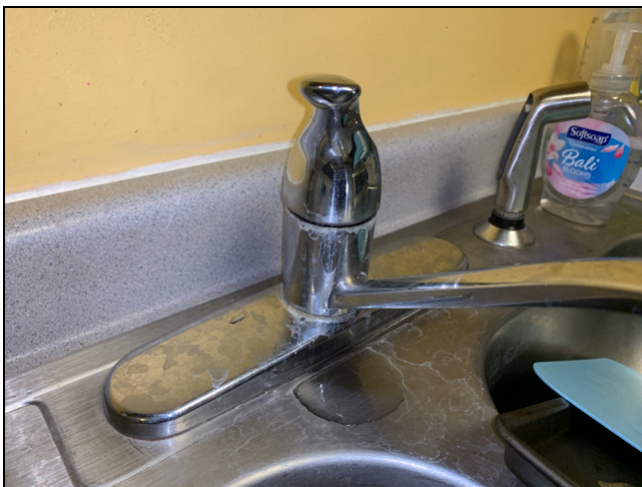
11.8 Item 1(Picture)

(1) Hardware at the kitchen sink appear to have an active leak, when the water source was turned on. This is an indication maintenance or replacement is likely.

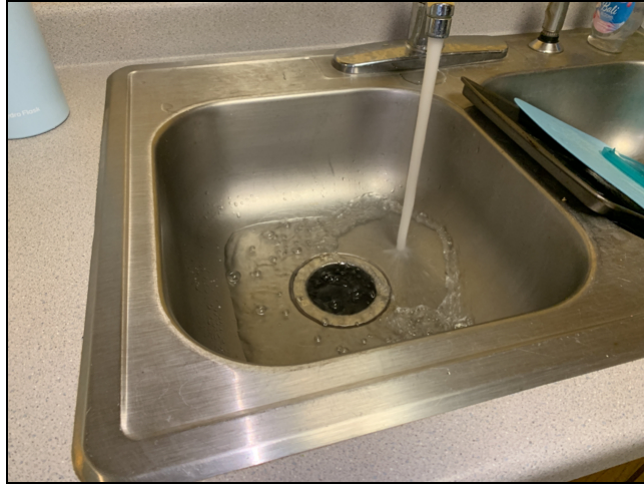
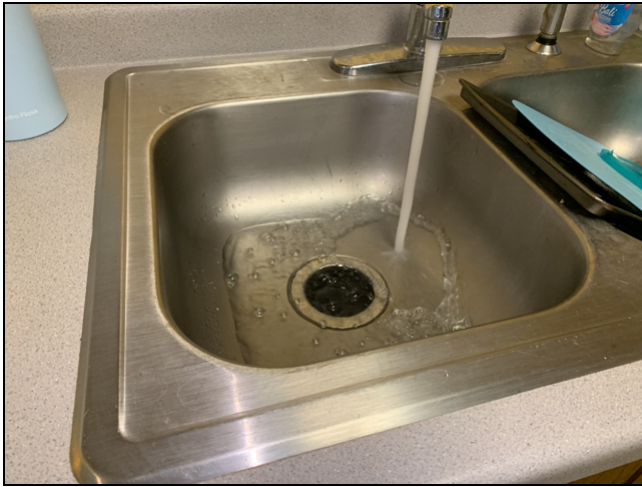
11.8 Item 2(Picture)

(2) The kitchen sink did not appear to be properly draining. Inspector recommends a qualified person or plumber further evaluate this finding to ensure proper conditions exist. Determining an exact cause goes beyond the scope of a home inspection. - see item 11.2 for more information.

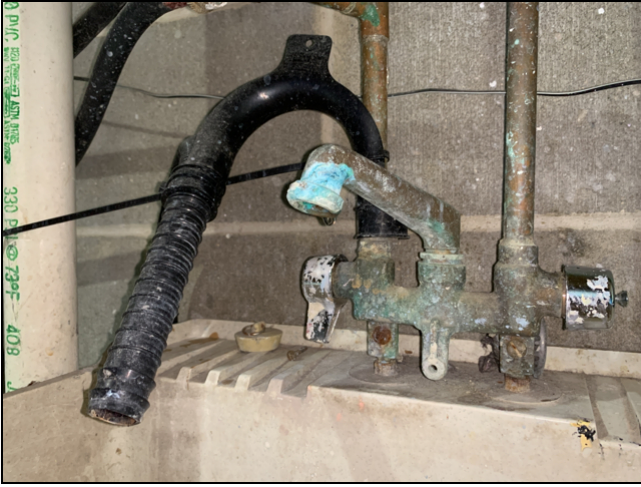
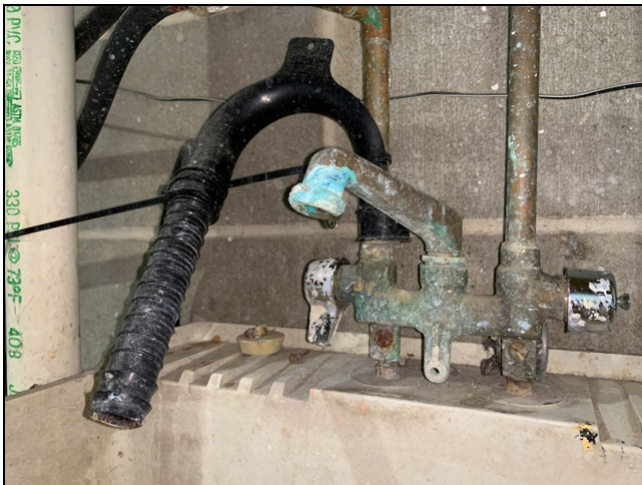
12.3 Item 1(Picture)

(1) Inspector observed what appeared to be an Active leak at the laundry room sink, when water source was turned off. This may be related to damaged hardware. Inspector recommends general maintenance, replacement of hardware is likely.

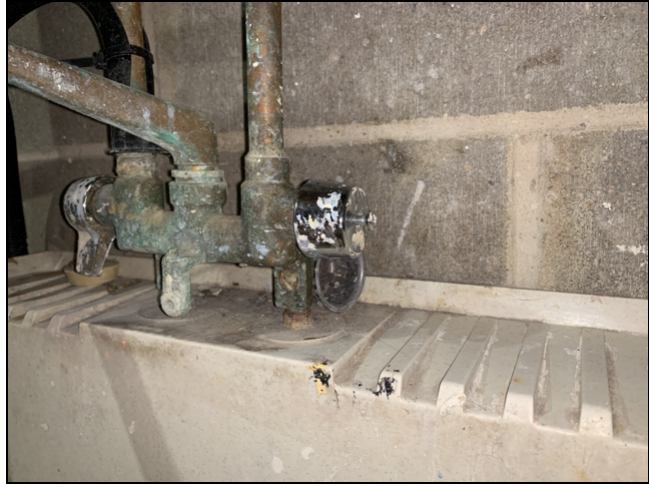
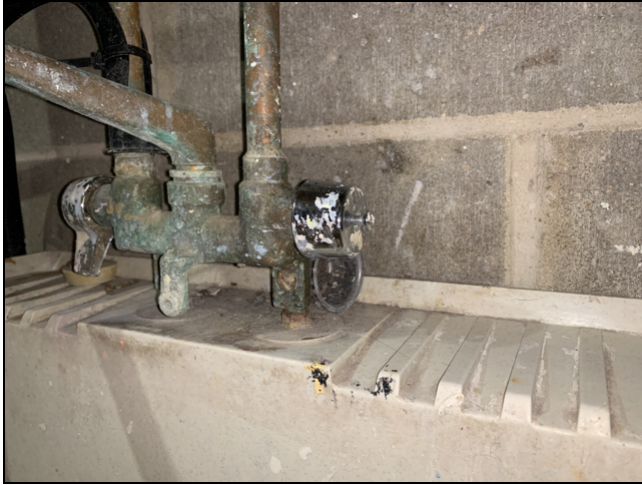
12.3 Item 2(Picture)

(2) Missing or damaged hardware should be replaced as needed. This is a maintenance item.
